Great yaw-acceleration and worn-out parts of restraint systems result in failure of three-point seat belts, specified for 70-kg heavy, 1.77 metre high passengers, conventional seat-rail assemblies and conventional seats to ensure the restraint of obese people such as millions of Europeans as well as 51 million Americans according to TIME of 07/01/02

A 4-year and 9-month old AUDI A3 on wet lane, when being out of control, crossing over the opposite lane, being crashed at the wheel-housing section by a Ford Fiesta, power plant of which, intruding into the passenger cell, severely injures the female driver, is yaw-accelerated counterclockwise about the vertical axis by about 390° . The pointer of tachometer at 80 km/h documents the crash speed of AUDI A3. The slim driver, being protracted by a belt retractor, suffers lacerations and bruises at his breast. In contrary to him, great energy of the female co-driver, whose weight Police Officer POK Kürtell estimates about 100 kg, is absorbed by a 10 to 12-litre head airbag and by an inner door-cover, her seat backrest, which is laterally deflected to 50 mm, and her collar bone, which is broken when her right arm is sustaining thereagainst

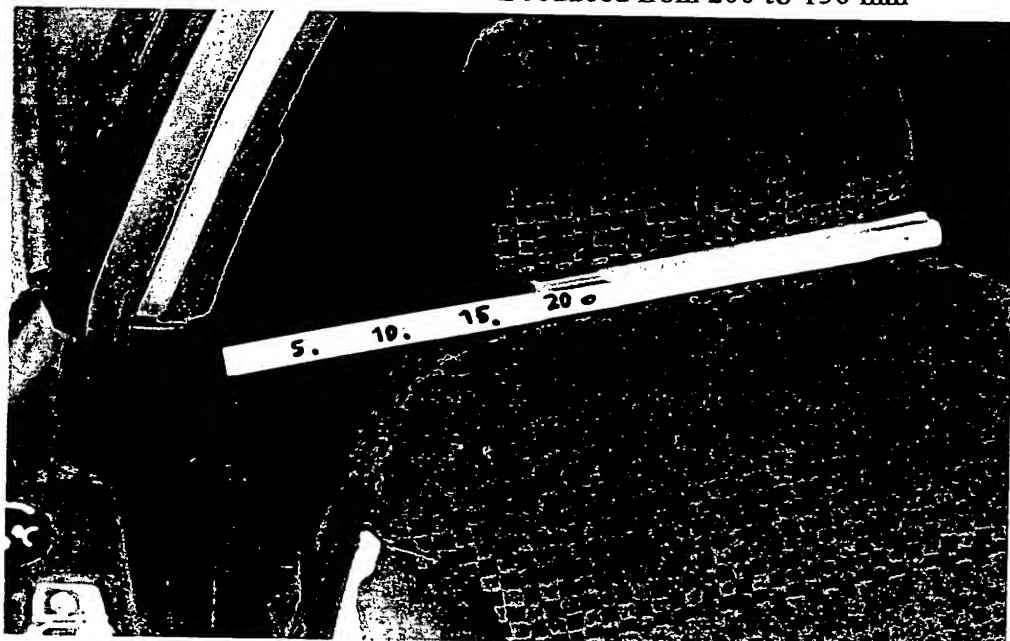
Total deformation of inner cover of B-pillar and seat backrest, whose distance to B-pillar is reduced from 200 to 150 mm

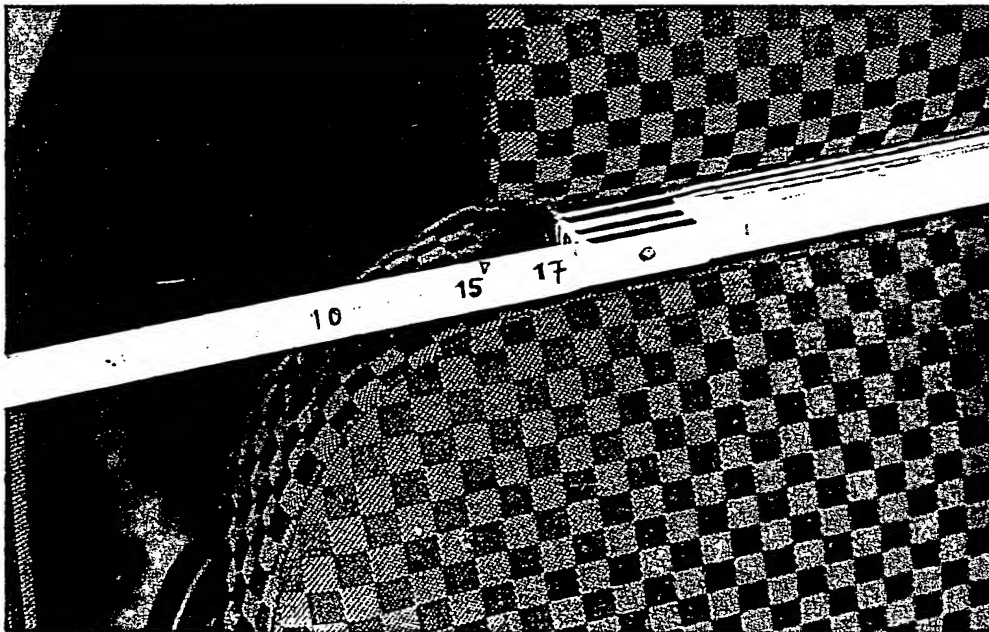
Distance to B-pillar from 200 to 150 mm

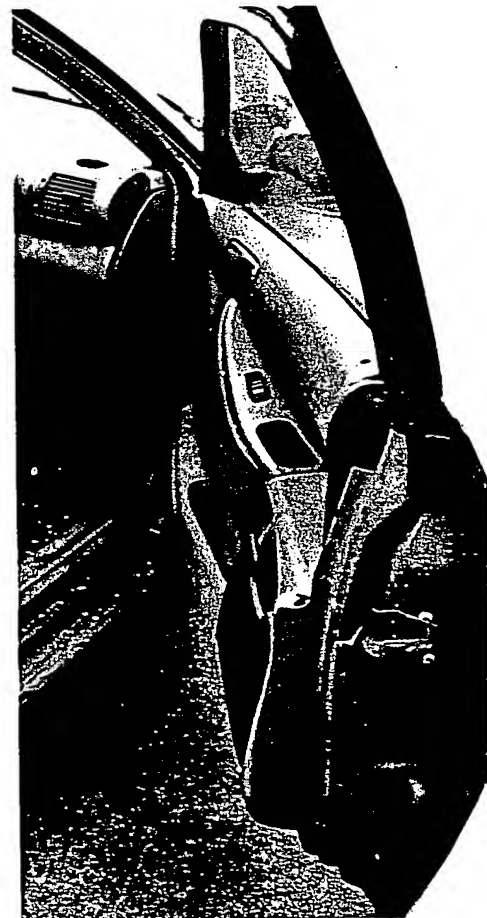
Total deformation of inner cover of door

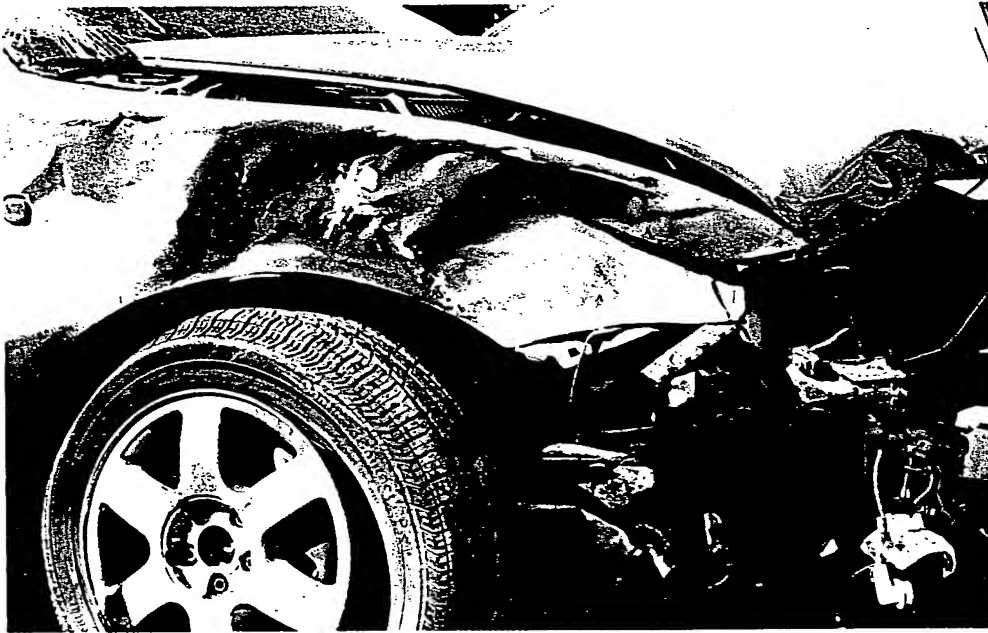
the wheel-housing of AUDI A3 stained by red colour of Ford Fiesta

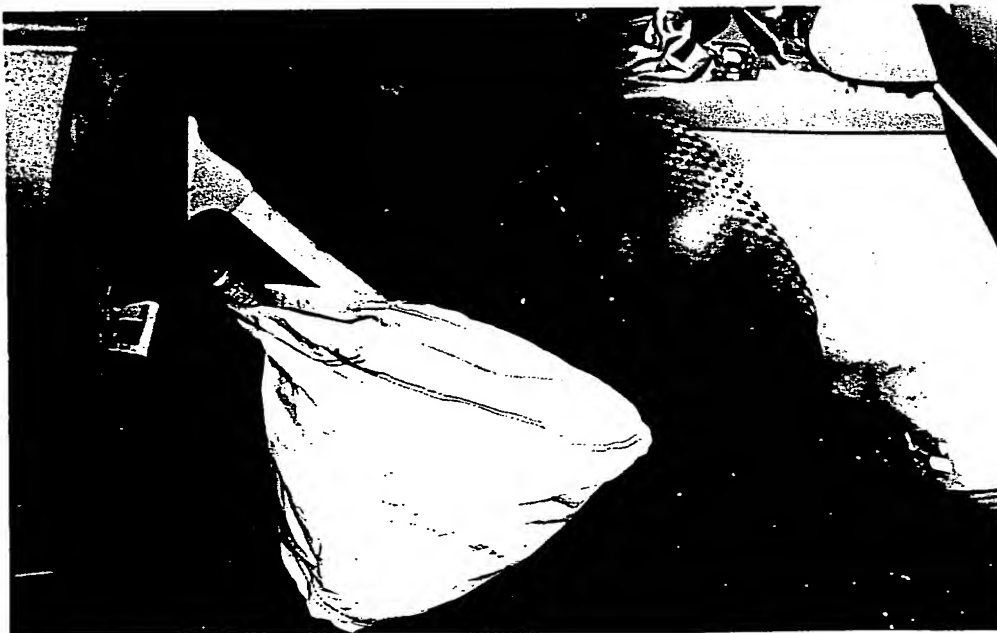
toylike head airbag of AUDI A3
